Australian

RAILWAY

HISTORY™

Journal of the Australian Railway Historical Society

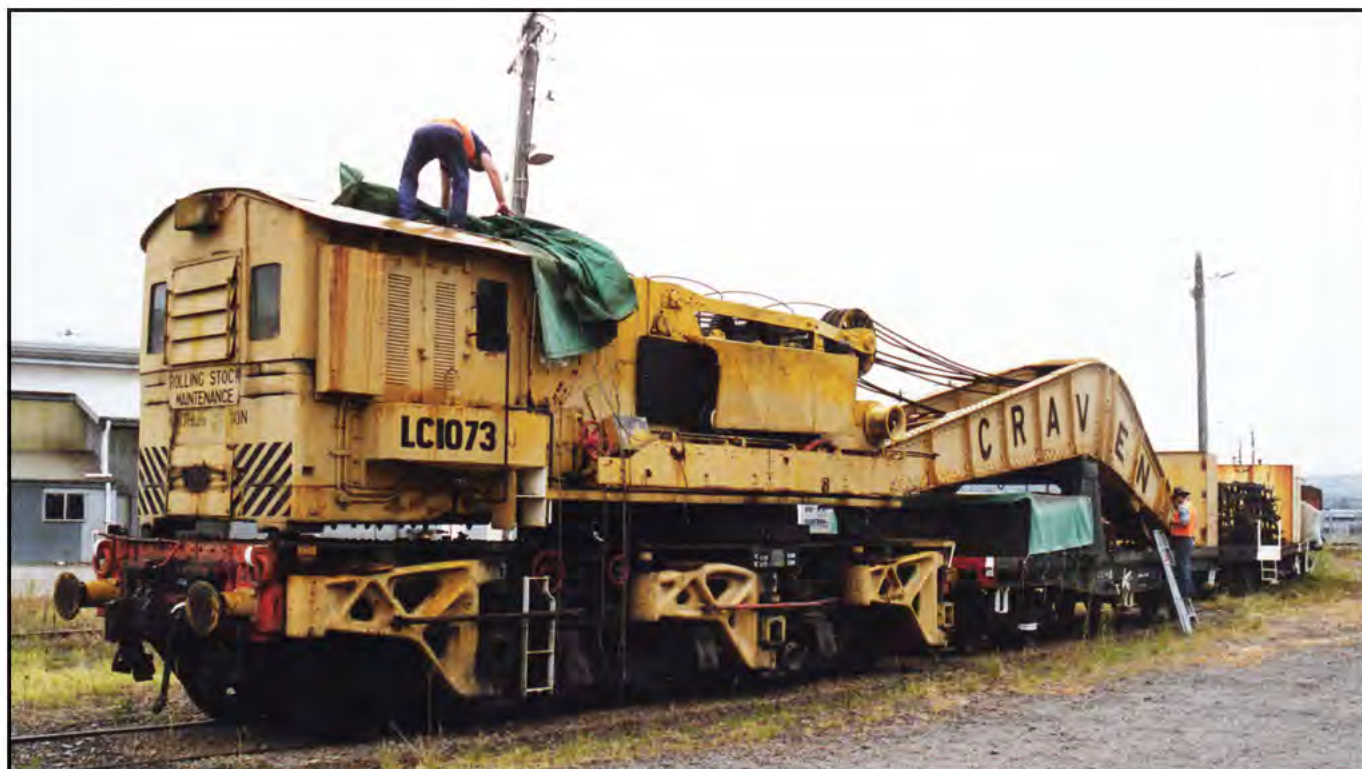
The Craven 70-ton capacity diesel breakdown crane LC 1073 at Broadmeadow Depot in the 1990s. ALAN PARKINSON COLLECTION

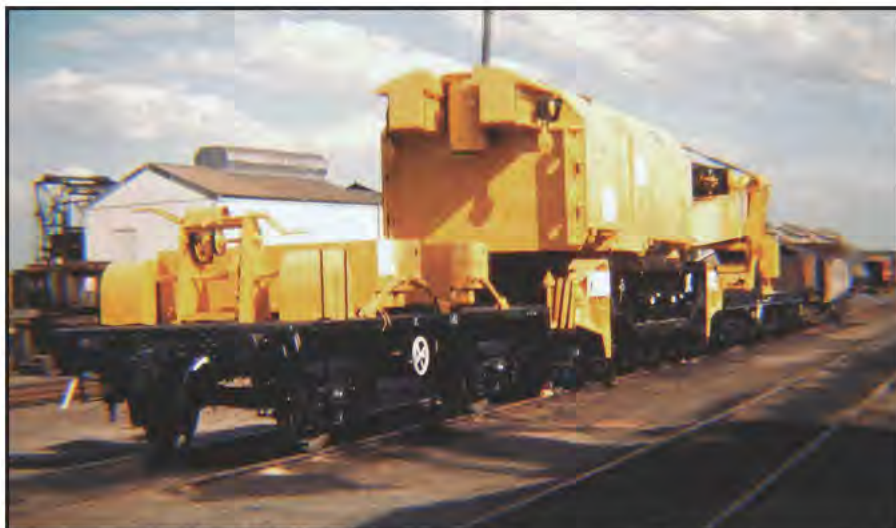
The Krupp crane at Enfield after upgrading to 150-tonne capacity. It was subsequently based at Lithgow Loco Depot. ALAN PARKINSON COLLECTION

Towards the end of 1959, a decision was made to convert the two Craven 60-ton cranes from steam to diesel operation, increasing their lifting capacity to 70-tons. After further investigation, an order was placed with the Krupp Company in Germany to supply two steam-powered cranes each capable of lifting 120 tons. These cranes arrived in the early 1950s, but only one was assembled. Being steam-operated, there were operating difficulties, so the crane was set aside at DELEC in Enfield for many years. Some years later this crane had its main beam bent at an accident site, so it was replaced from the non-assembled crane. The second crane was never assembled.

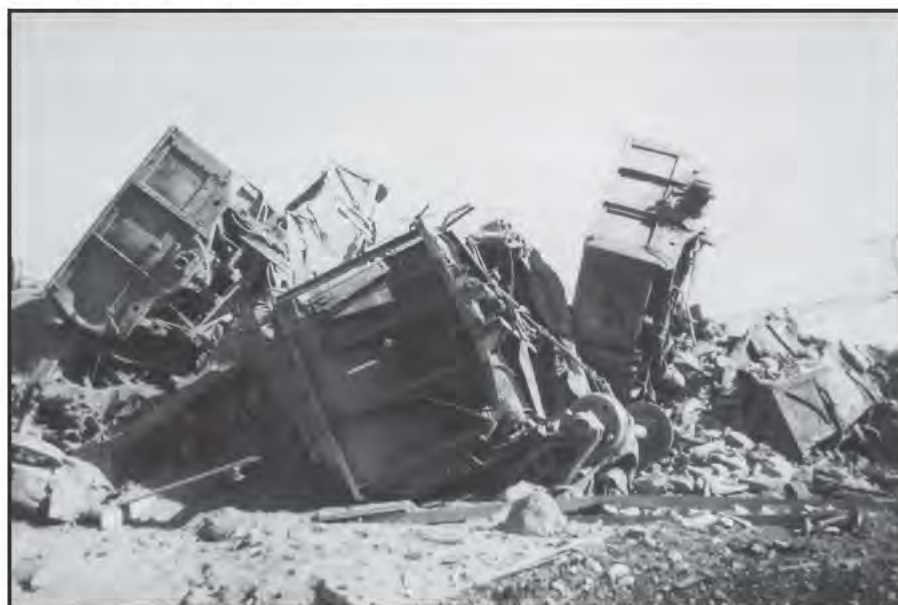
Piled-up wagons in the yard at Wentworth Falls following the derailment there in the early hours of 17 July 1965. CLIVE KEENAN PHOTO

The whole area was covered with cement, slag and bogie goods wagons such as BCH and BRH hoppers, together with four-wheel S, K and RU four-wheel trucks. Three bogie louver wagons were in a tangled heap, while several BCH coal hopper wagons were found in the front of houses of a nearby street. Out of the dust and cement, an old lady still dressed in her night attire emerged upset that

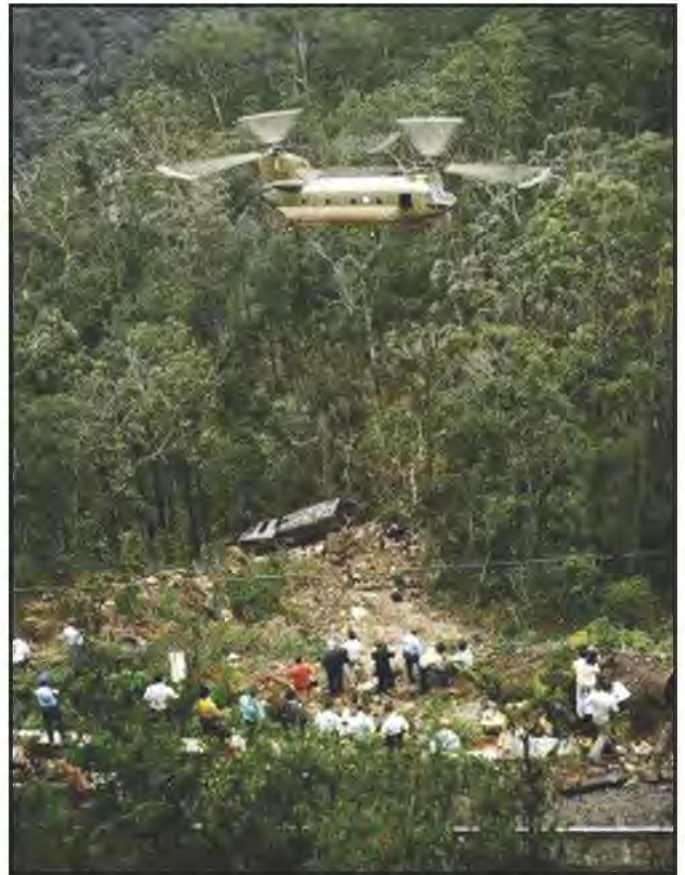
The RAAF heavy-lift helicopter preparing to raise a cut-up section of the V-set driving trailer car from the gorge adjacent to Glenbrook Tunnel in January 1976. CLIVE KEENAN PHOTO

The officer in charge of the Special Forces group inspected the sling and said we would find ourselves in trouble. An inspector from the Air Force Safety Bureau was standing on the main line with railway officials. He quickly made his way down the mountain to examine the problem. In response to my query regarding what could be done next, he explained that the equipment had been 'pinched' from the Americans in Vietnam. It had been found in a container 'half full of sea water' on a beach. When the inspector examined the break, I explained that it was possible I had underestimated the weight of the carriage. Fortunately there were no injuries and the damaged carriage was only to be used for scrap.

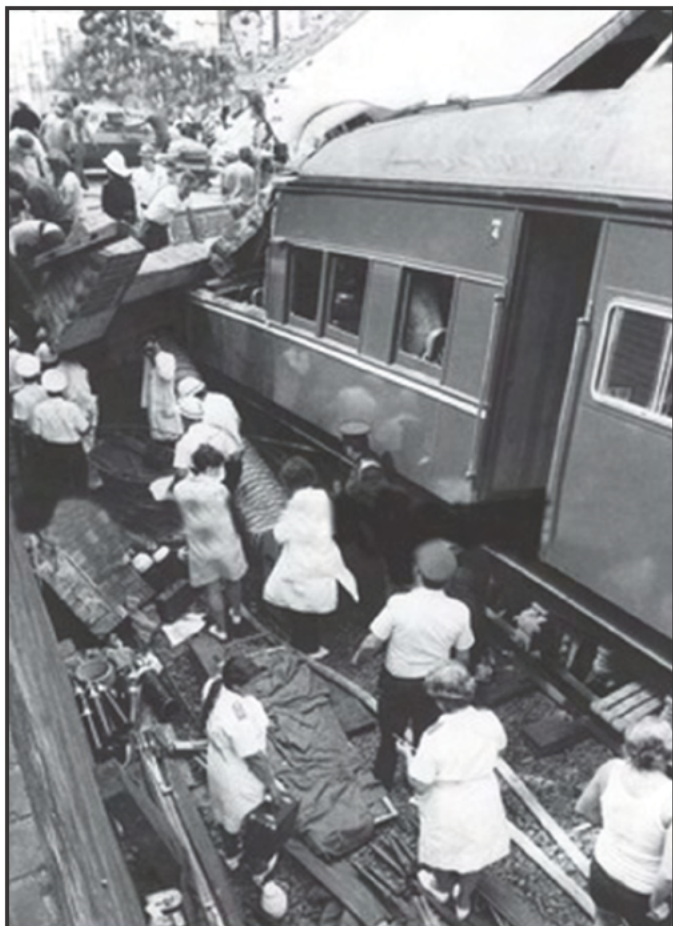
Rescuers assisting injured passengers in the crushed carriages under the Bold Street overbridge, 18 January 1977.
BOB O'LOUGHLIN PHOTO

I sent my gang to place our 120-tonne MFD jack around the bridge structure, which had crushed carriages three and four. I could hear a voice under the rubble, so I crawled beneath the concrete slab to find a young man trapped beneath another steel section of the bridge. A paramedic officer climbed into this section with me together with Les Dukes, one of my crew. We inserted a 20-ton MFD jack to lift the steel section while the paramedic administered pain-killing drugs to the man.

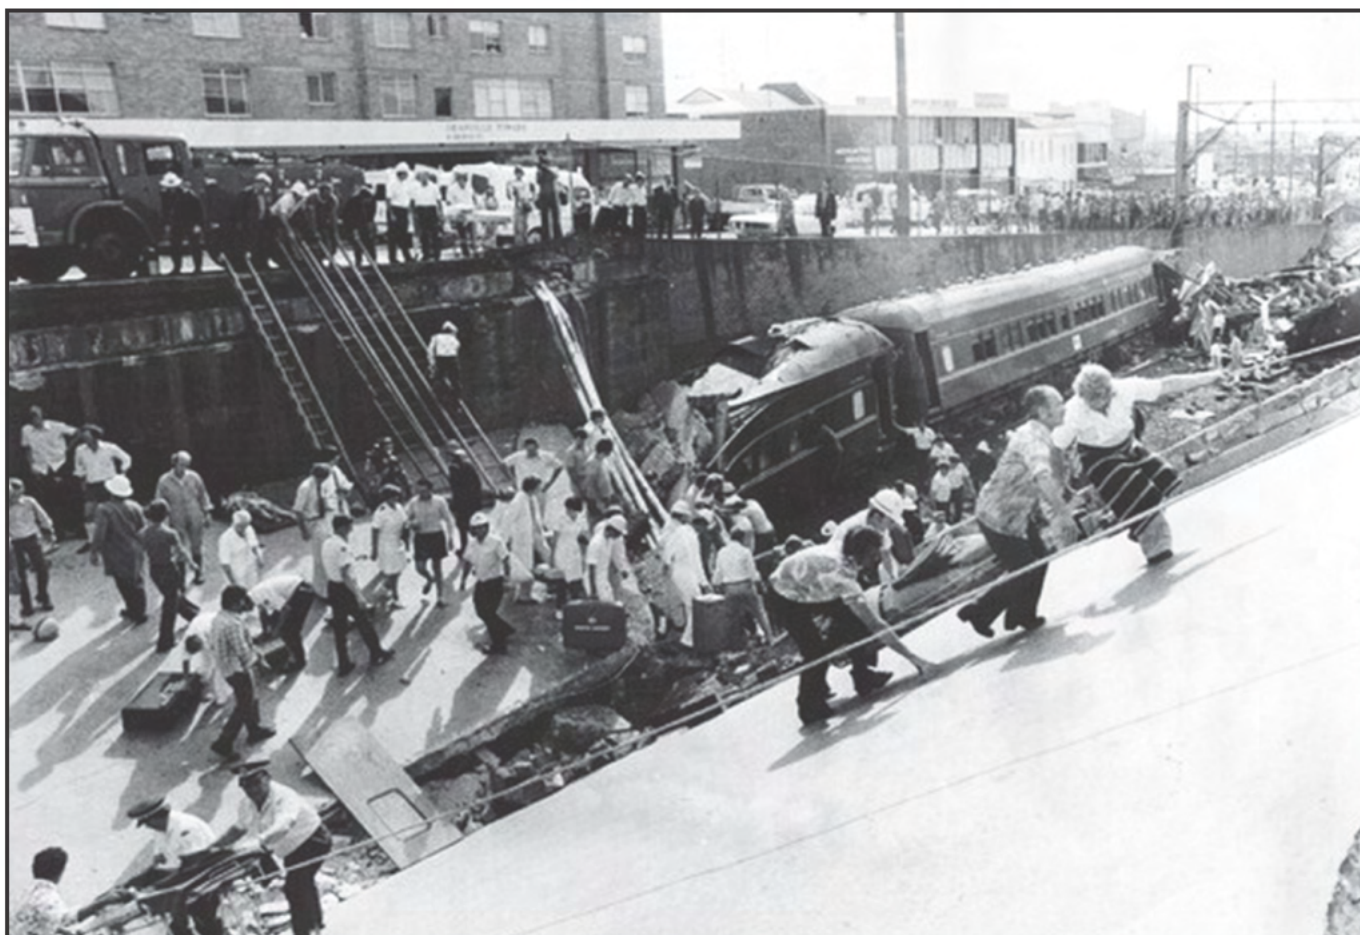
Rescuers setting ropes to lift the Bold Street overbridge from the crushed carriages using MFD hydraulic jacking equipment.
BOB O'LOUGHLIN PHOTO

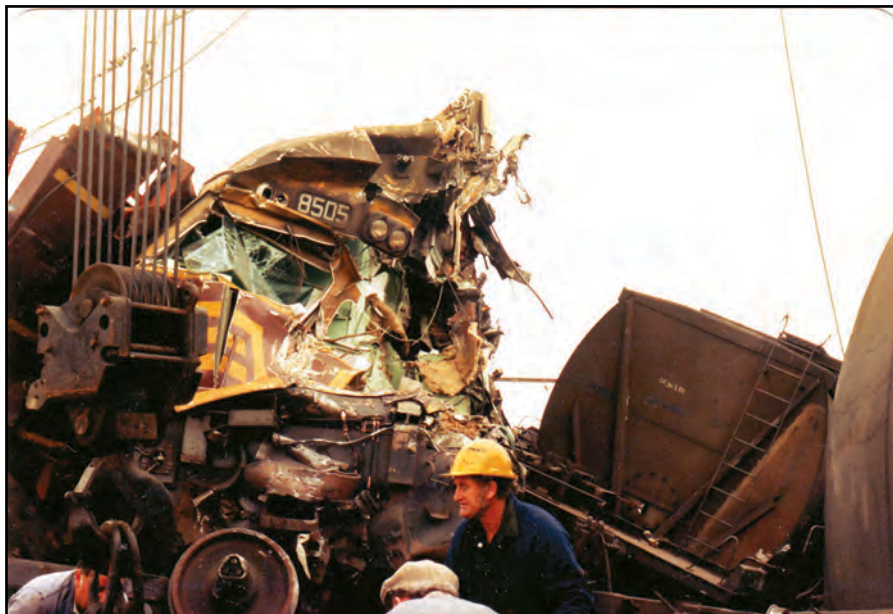
Rescue workers place the hook of a mobile crane to lift damaged wheat hopper wagons at Valley Heights on 19 July 1982. The tangled mess of electric locomotive 8505's driving cabin is evident. TED DIXON PHOTO

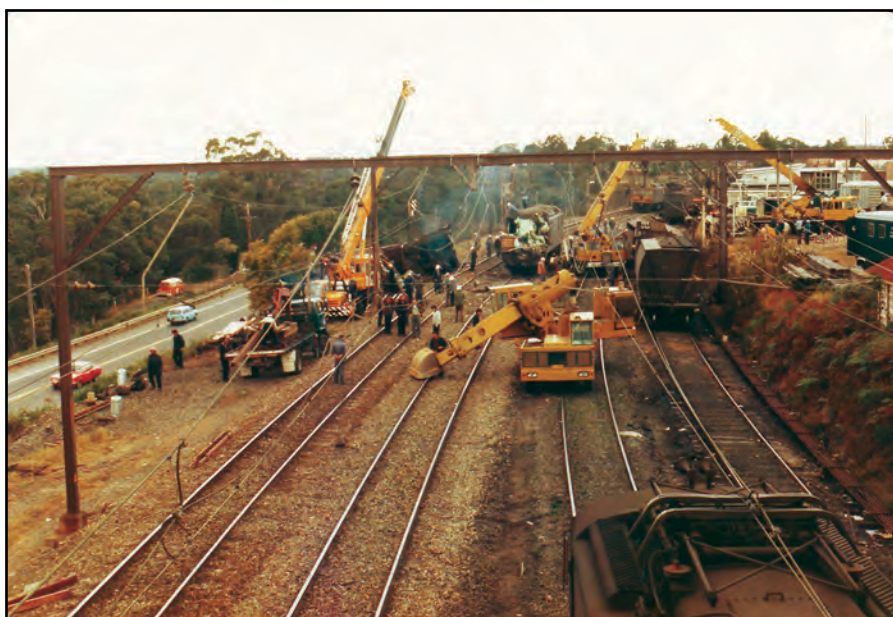
The accident gang and mobile cranes clearing the accident site at Valley Heights in July 1982. TED DIXON PHOTO

Ray Hull asked how should we attack the mess before us? I proposed we obtain the services of two new 30-ton capacity mobile cranes that had been allocated to the Clyde Wagon Workshops, so Ray asked if we could get the cranes that day. I agreed to check this out with the Clyde Works manager, Jack Gearin, as I had previously worked with him at the Chullora Rollingstock Aircraft Workshop and had his phone number. The cranes arrived and we quickly lifted all the

damaged vehicles and replaced their bogies, before placing them in the wagon repair road at the Valley Heights Depot to await repair, while the guards van was placed on a semi-trailer and taken to the Clyde Wagon Workshops. This was another example of using mobile cranes to avoid disturbance of overhead electric wires, which would have been necessary if the 70-ton rail-mounted crane was used.

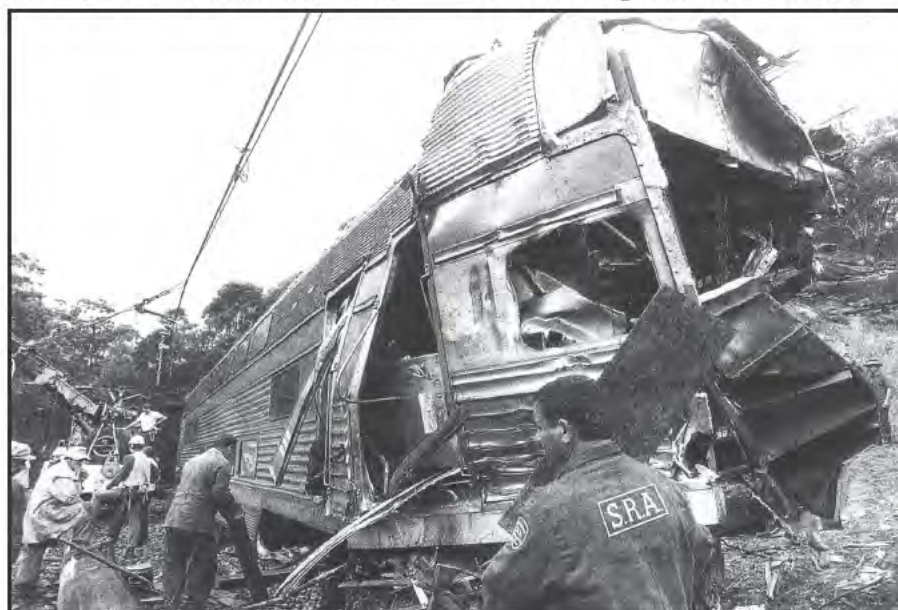
SRA breakdown teams removing the debris from the driving car of the V Set following the collision with the stalled heritage train hauled by locomotive 3801, 6 May 1990. STEVEN STEWART, SYDNEY MORNING HERALD, ALAN PARKINSON COLLECTION

As I described my assessment, which he accepted, he asked me: "Are you going to do another Glenbrook?" I responded: "No, our plan is to clear 3801 away to Hornsby with its train, leaving the smashed rear carriage on site and clear the damaged interurban train to Gosford." 3801 and its train was sent to Cowan sidings for examination.

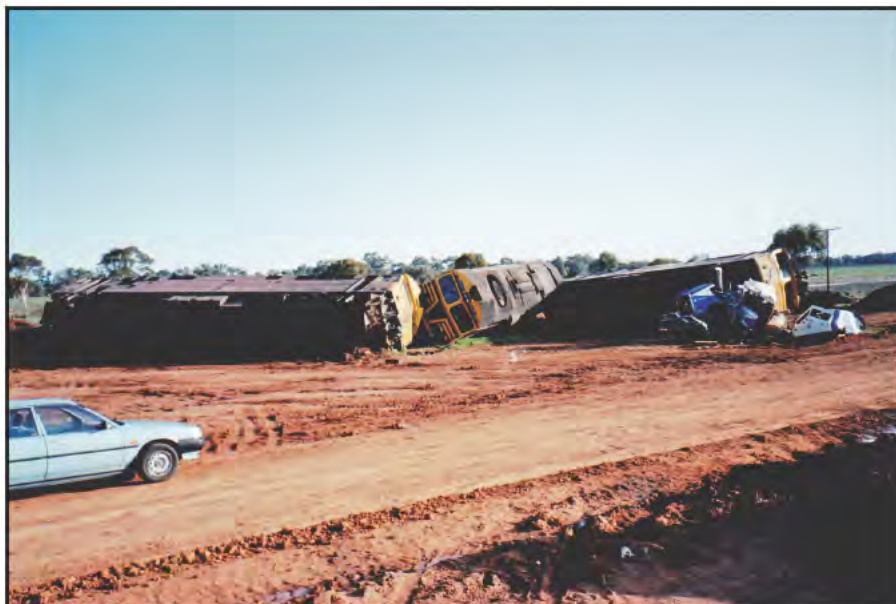
The three 80 Class diesel-electric locomotives in the paddock at Yarrabandai together with the tangled remains of the semi-trailer, August 1992. BOB O'LOUGHLIN PHOTO

The leading locomotive was on its side and at least 50 metres from the track. Both its bogies were intact and attached to the underframe. The fuel tanks were also intact, so it appeared that all three locomotives had a soft landing in the paddock. There was some structural damage to all the locomotives, while the semi-trailer had been demolished, it was fortunate that the driver was not in the cabin at the time of the impact.

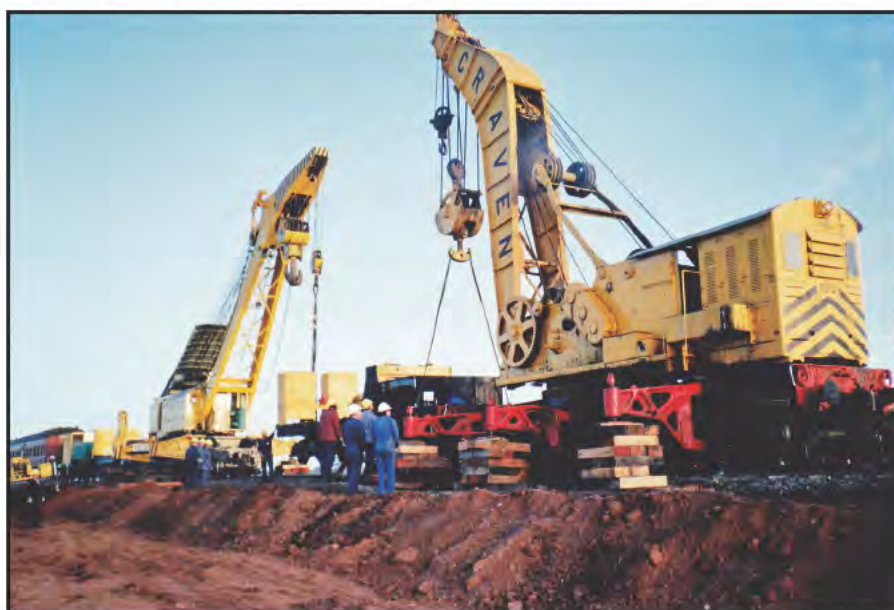
Setting up the heavy cranes by attaching concrete weights to balance both cranes prior to dragging each locomotive up to the track. BOB O'LOUGHLIN PHOTO

Our team members agreed that we would require both accident cranes and we would need exclusive use of the main line for the recovery operation. Accordingly, all interstate freight and long-distance passenger services would have to be diverted via Melbourne to allow each of the locomotives to be brought up to the main line and moved to their destination. Initially, each locomotive was lifted with MFD jacks to enable sleepers and rails to be placed under the locomotive. This would allow the cranes to drag the locomotives closer to the track for lifting, thereby avoiding further structural damage.

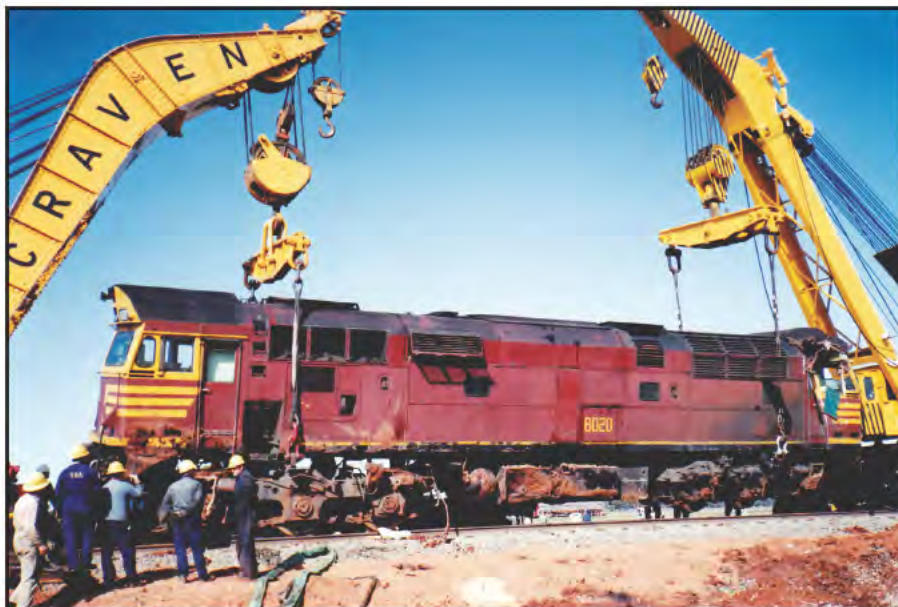
The Craven and Krupp the breakdown cranes lifting damaged locomotive 8030 onto the track near Yarrabandai in August 1992. BOB O'LOUGHLIN PHOTO

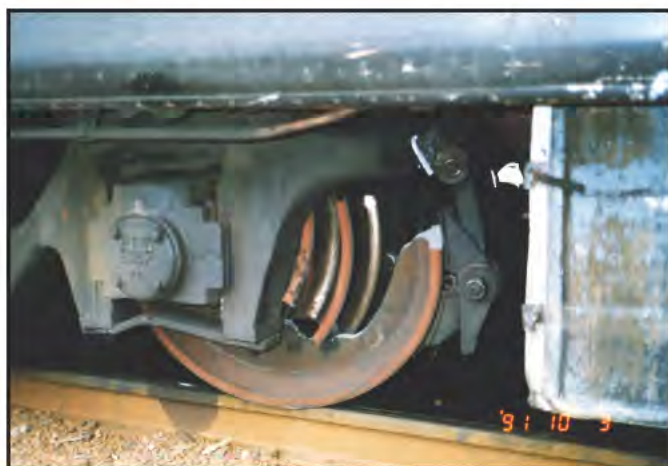
The shattered leading motor bogie driving wheel of trailing DEB motor car 958 at Nowra on 9 October 1991. BRIAN ARNDELL PHOTO

In late 1991 a 900 Class diesel train on a Wollongong to Nowra service was approaching its destination when the leading motor bogie wheel in the trailing motor car No. 958 failed. The driver heard a loud noise when approaching the station, so he went to check what had occurred. To his astonishment, a wheel set had broken through the carriage floor, but for some strange reason the bogie had not derailed.

delivered. Martin went through the old CME files and, to our surprise, he located the complete file there. Much to our surprise, there was no evidence of a directive to replace wheel sets when new motor bogie wheels became available, so trailer wheels had evidently been used ever since.

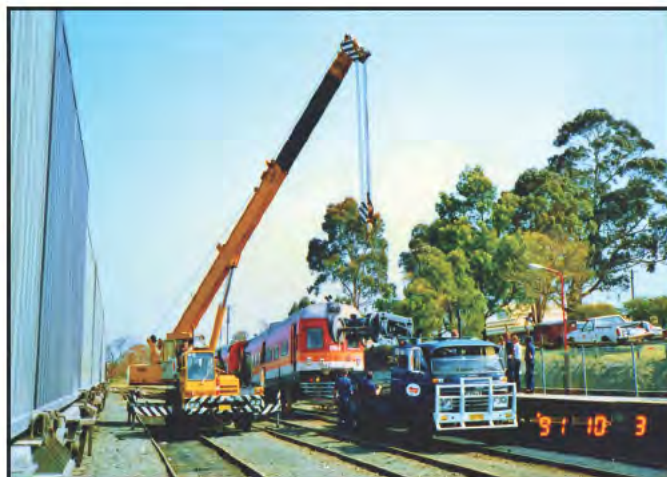
The mobile crane, having lifted the rear DEB motor car No. 958, is lifting the damaged motor bogie onto a SRA lorry at Nowra on 3 October 1991. BRIAN ARNDELL PHOTO

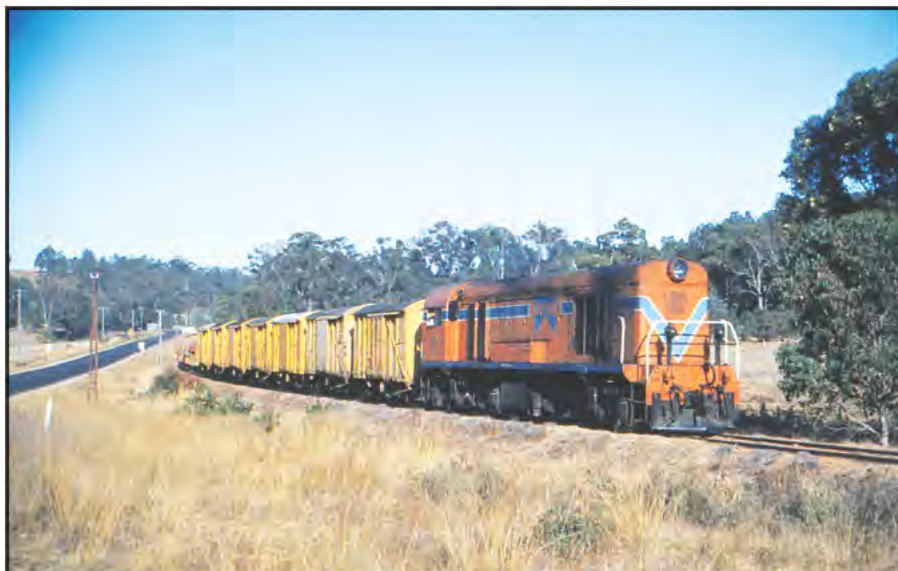
Former Midland Company of WA Co-Co English Electric 1030hp diesel-electric locomotive G50 heads a freight train out of Donnybrook beside the Donnybrook-Boyup Brook Road on 23 March 1984. Following the reopening of Bunbury as a grain export port, this road carried high levels of road-based grain transport from the Great Southern Region.

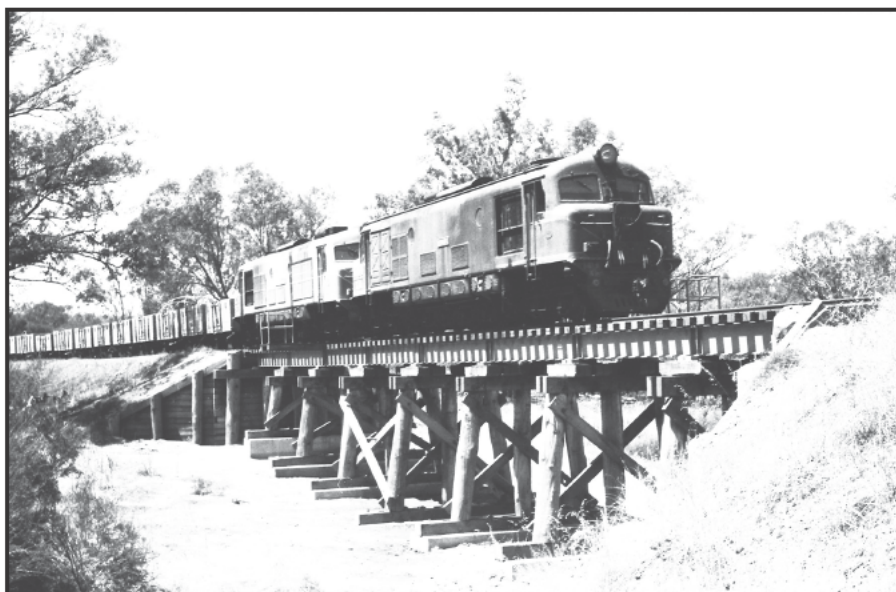
Xa Class 2-Do-2 diesel-electric locomotive 1406 UNGARINYIN and Xa 1411 WEEDOOKARRI head a train of empty wagons across the steel girder truss bridge east of Boyup Brook. RAIL HERITAGE WA PHOTO, P11119

With their rigid frames, the 2-Do-2 Metropolitan Vickers locomotives were not kind to light tracks, and it appears they banged the permanent way around in a similar manner to their sister locomotives on the Meekatharra line. Derailments were not uncommon. A case in point being the incident on 29 December 1982 when XB 1022 *KARDAGUR* and XB 1017 *EWENYOON* derailed with a Boyup Brook train near Newlgalup. The damage resulted in *KARDAGUR* being permanently withdrawn from traffic. Examples of latter-day rostering include the following:
